RESIDENTIAL REPORT  
Condo on the Bay Tower II  
Association 988 Boulevard of the Arts  
Sarasota, Florida 34236

Phase One Milestone Inspection

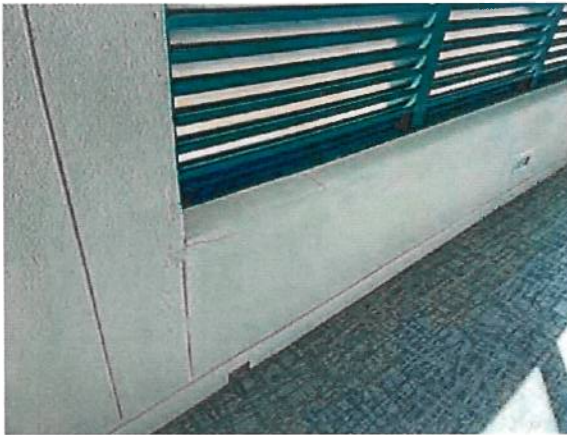
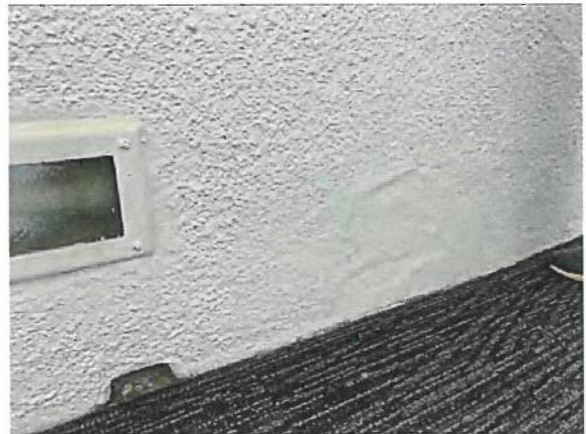
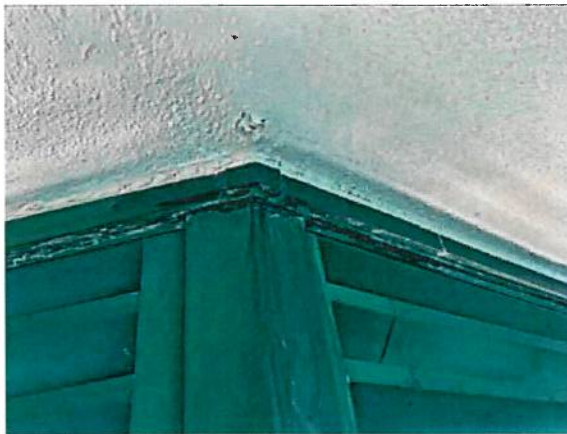
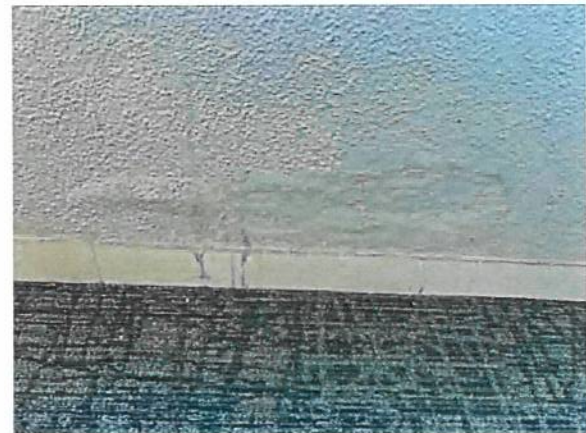
1.o.1.0

1. Interior paint peeling toward the top of pedestal walls below ventilation louvers in the interior walkways between units.
2. Minor exterior paint chipping/peeling at walls at various locations.
3. Minor cracks in concrete stairs and CMU walls of staircases.

Minor cracking and spalling observed in multiple areas. Above mentioned areas with spalling should be patched and sealed.
